Stones & Dewel ventilator etch

Stones (6 or 9 pane) & Dewel (5 pane) ventilators were used in late Midland Railway gangwayed carriage designs, and carried through to LMS period 1 and period 2.

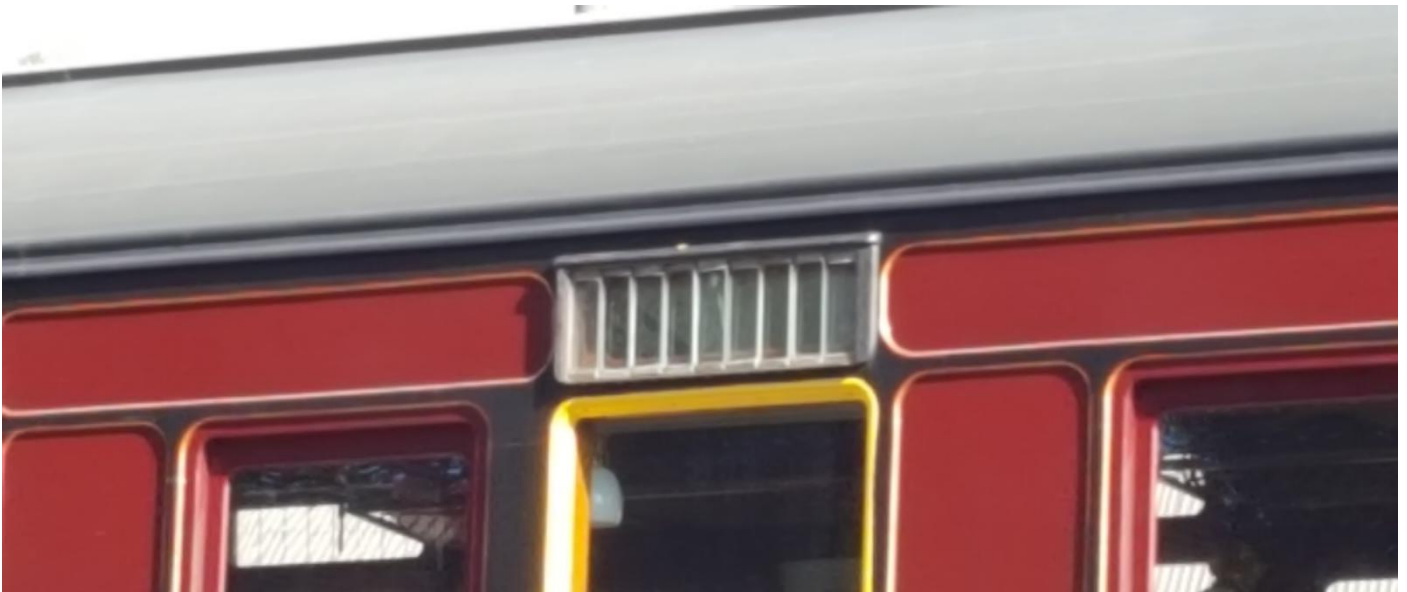
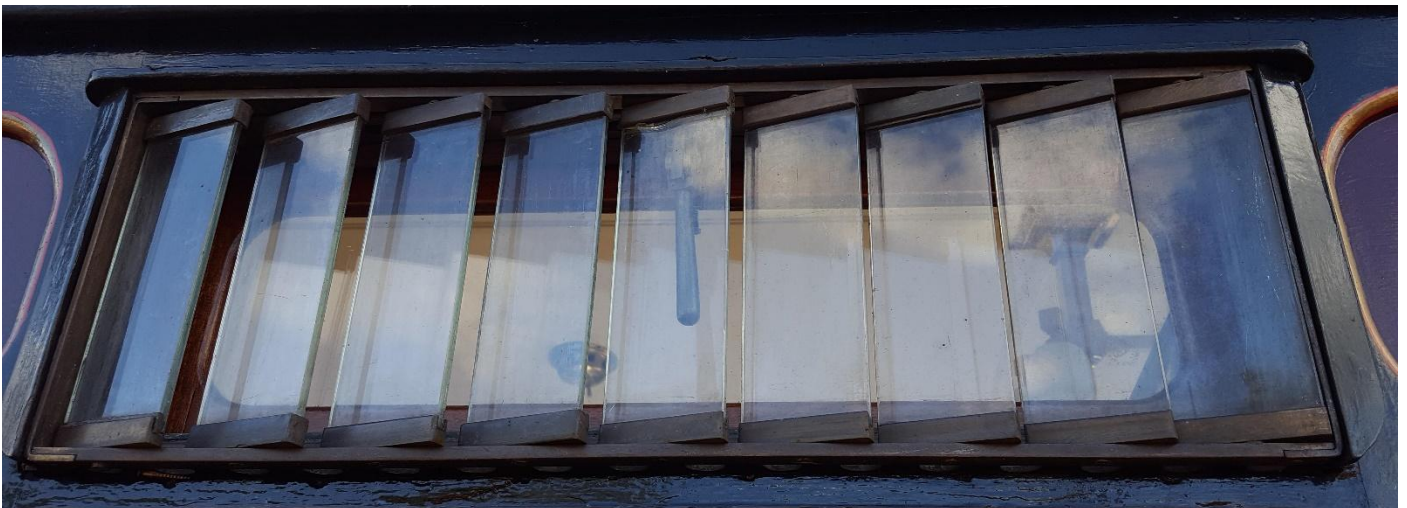
The below photos (taken by myself at Peak Rail) show how the prototype item looks, and shows that the inner shutter frame can be seen.

Note that there is a lip at the top edge of the vents, so there is a 'right way up' to fit them.
